**“INSPECCIÓN VISUAL DE  
HUNDIMIENTOS Y RAJADURAS EN  
LA PIEL DEL EMPENAJE EN LA  
AERONAVE HAWKER SIDDELEY DE  
ACUERDO AL SRM ATA 51 Y 55  
MEDIANTE LA TARJETA DJI A3 EN EL  
CUADRICOPTERO CFLM  
PERTENECIENTE A LA UGT – ESPE”**

Chicaiza Byron

Presentación de la Monografía

Diciembre, 2019

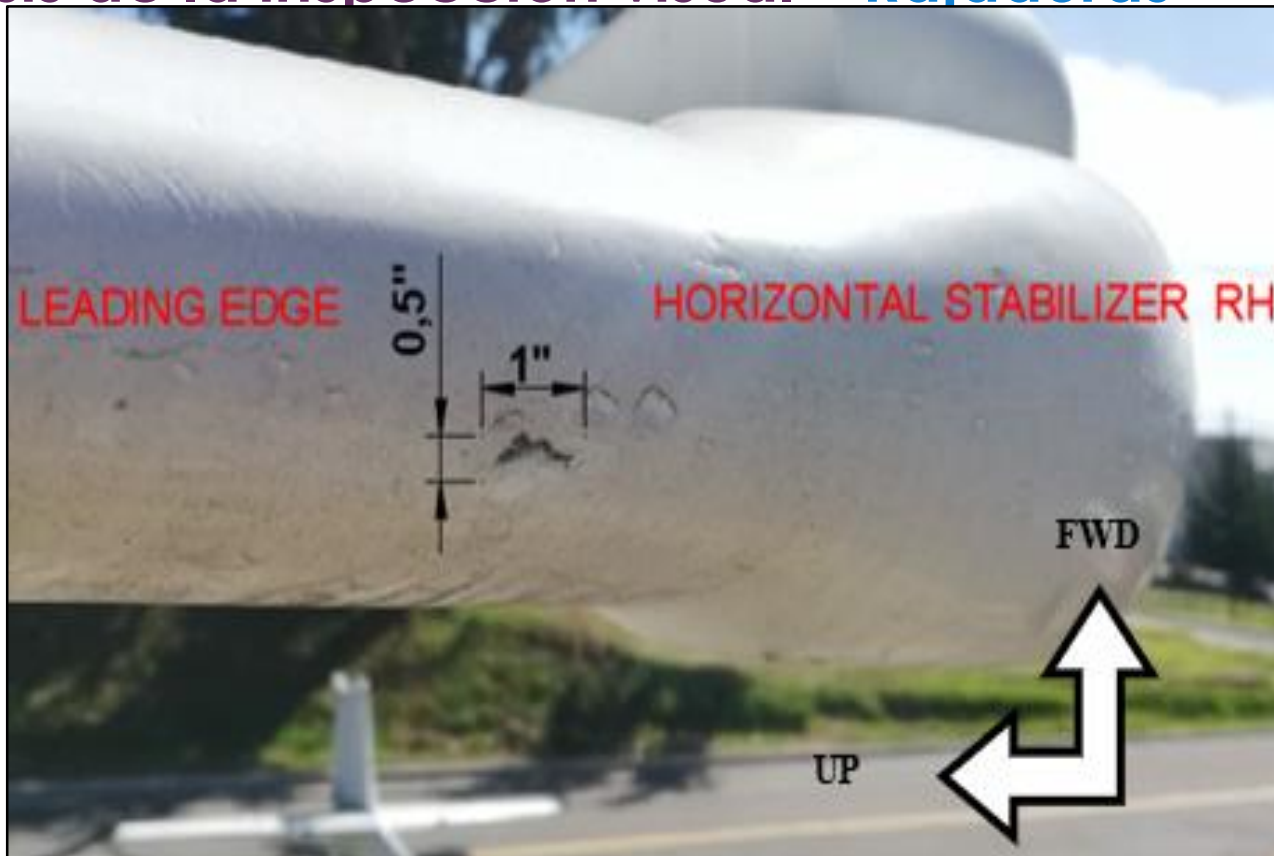
## Análisis de la inspección visual – Rajaduras

Small spots of damage on the surface of any skin panel, caused for example by lightning or impingement of hard small objects, may be considered allowable damage if no larger than 5/32 in. (0.156 mm) diameter, no closer than 1.00 in. (25.4 mm) apart and when blended out and polished do not exceed 0.005 in. (0.127 mm) in depth.
