DEPARTAMENTO DE CIENCIAS ESPACIALES CARRERA DE MECÁNICA AERONÁUTICA MENCIÓN AVIONES

MONOGRAFÍA PREVIO A LA OBTENCIÓN DEL TÍTULO DE TECNÓLOGO EN MECÁNICA AERONÁUTICA MENCIÓN AVIONES

TEMA: “INSPECCIÓN VISUAL POR HUNDIMIENTO Y RAJADURAS EN LA PIEL DE LAS ALAS DE LA AERONAVE FAIRCHILD FH-227, MEDIANTE LA IMPLEMENTACIÓN DE UN SISTEMA FPV (VIDEO EN TIEMPO REAL), EN EL CUADRICÓPTERO CFLM PARA LA UGT-ESPE”

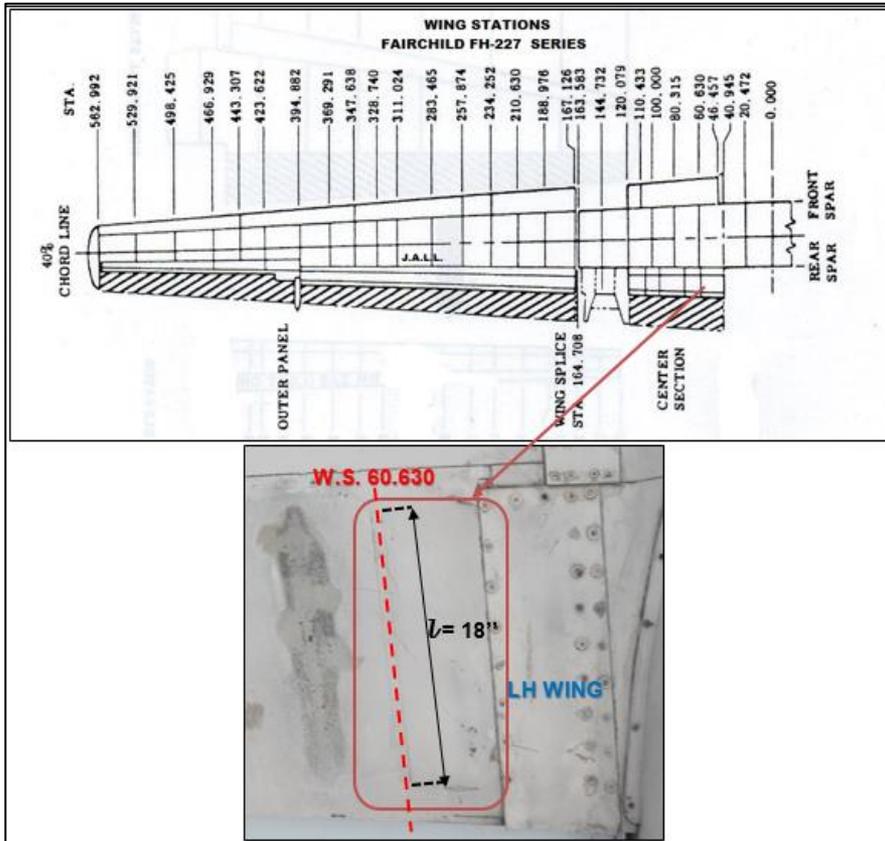
WING CENTER SECTION

- REPARACIONES - RAJADURAS - HUNDIMIENTOS - DISCREPANCIAS ADICIONALES

A. Negligible Damage.

Skin surface scratches which do not penetrate the alclad coating may be classified as negligible when smoothed out by polishing or burnishing to a 63 file finish. Smooth dents that are free of nicks or cracks are also considered to be negligible if they can be tapped into shape. Holes and cracks that can be cleaned out with a 1/4 inch diameter drill, and then plugged with a soft rivet, are also classified as negligible damage.

B. Damage Repairable By Patching.

The affected area must be repaired by patching if any of the above limits are exceeded, or for any other type of damage not listed.

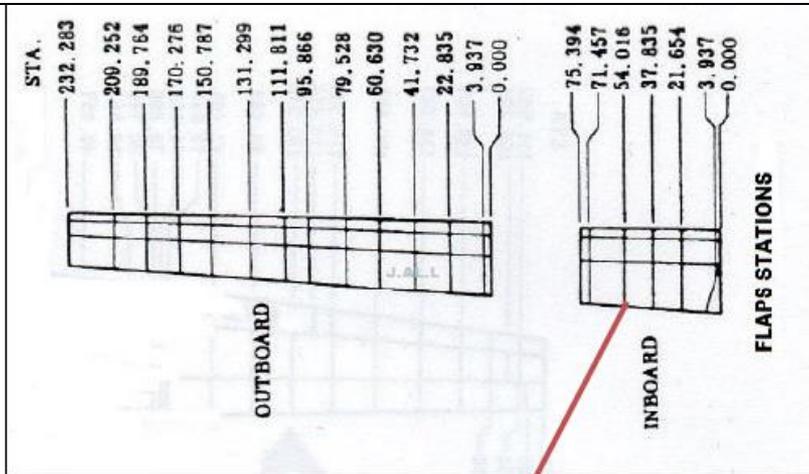
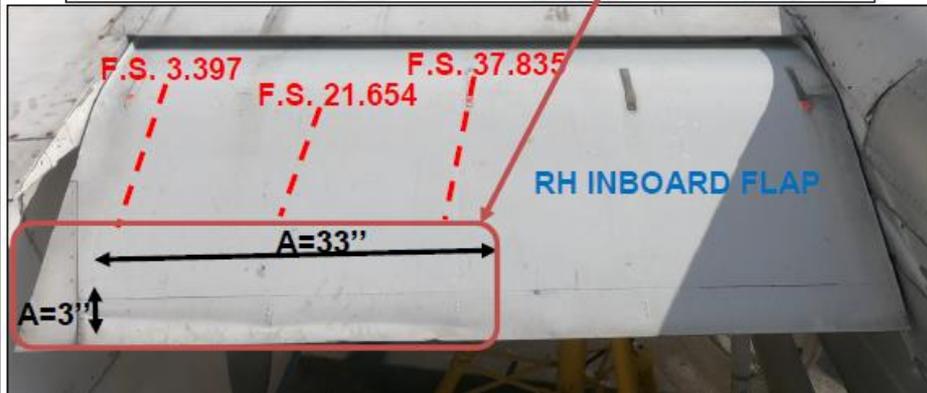
INBOARD FLAPS

- REPARACIONES - RAJADURAS - HUNDIMEINTOS - DISCREPANCIAS ADICIONALES

A. Negligible Damage.

Skin surface scratches which do not penetrate the alclad coating may be classified as negligible when smoothed out by polishing or burnishing to a 63 file finish. Smooth dents that are free of nicks or cracks are also considered to be negligible if they can be tapped into shape. Holes and cracks that can be cleaned out with a 1/4 inch diameter drill, and then plugged with a soft rivet, are also classified as negligible damage.

B. Damage Repairable By Patching.

The affected area must be repaired by patching if any of the above limits are exceeded, or for any other type of damage not listed.

CAUTION: CONTROL SURFACE STRUCTURE MUST BE SUPPORTED TO MAINTAIN ALIGNMENT WHEN SKINS ARE REMOVED AND REPLACED.

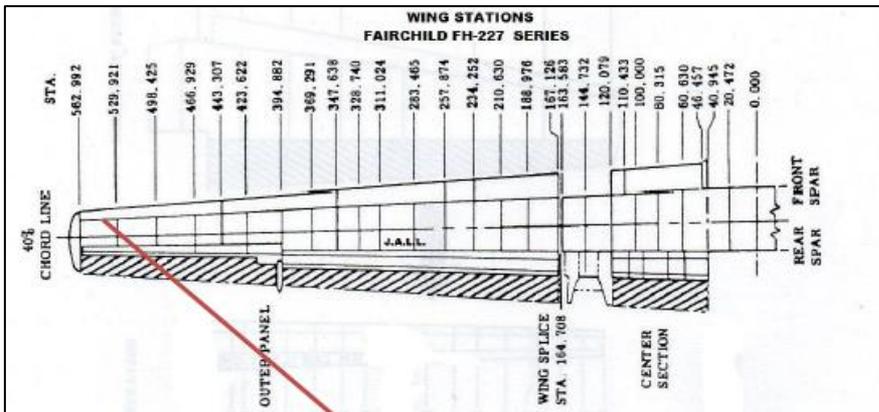
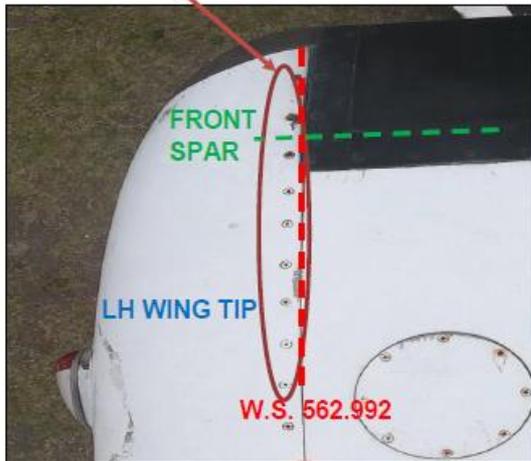
- REPARACIONES - RAJADURAS - HUNDIMEINTOS - DISCREPANCIAS ADICIONALES

- 6.53 Corrosion Removal Around Countersunk Fasteners in Aluminum Alloy.** In aluminum alloys, intergranular corrosion often originates at countersunk areas where steel fasteners are used. Corrosion removal in a countersink is impossible with the fastener in place.

- 6.53.1** When corrosion is found around a fixed fastener head, remove the fastener to ensure corrosion removal, prevent further corrosion, and prevent loss of structural strength. To reduce the reoccurrence of corrosion, the panel should receive a chemical conversion coating, be primed, and have the fasteners installed wet with sealant.

- 6.53.2** Each time removable steel fasteners are removed from access panels, inspect them for material condition, including the condition of the plating. If mechanical or plating damage is evident, replace the fastener. Upon installation, follow one of the below fastener installation methods:

- 6.53.2.1** A preferred method is to brush a corrosion preventive compound on the substructure around and in the fastener hole, start the fastener, apply a bead of sealant to the fastener countersink, then set and torque the fastener within the working time of the sealant;

- 6.53.2.2** Apply the corrosion preventive compound to the substructure and fastener, set and torque the fastener; or
 - 6.53.2.3** Apply a coating of primer to the fastener, and, while wet with primer, set and torque the fastener.
