Reparación y rehabilitación del sistema de combustible de la aeronave Cessna T206H de la compañía Aeromorona CIA-LTDA.

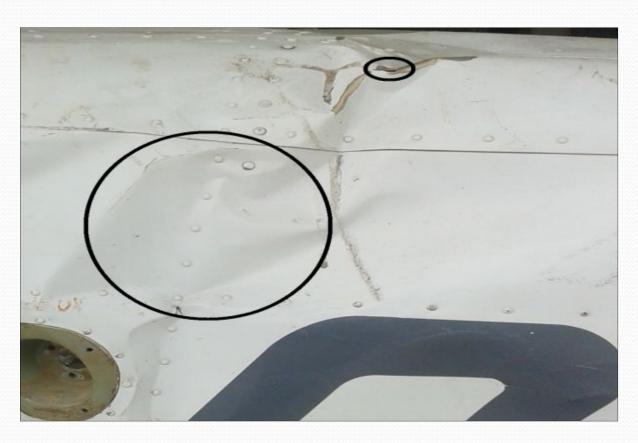
Delaminación del tanque de combustible.
