**“INSPECCIÓN VISUAL DE  
HUNDIMIENTOS Y RAJADURAS EN  
LA PIEL DEL EMPENAJE EN LA  
AERONAVE HAWKER SIDDELEY DE  
ACUERDO AL SRM ATA 51 Y 55  
MEDIANTE LA TARJETA DJI A3 EN EL  
CUADRICOPTERO CFLM  
PERTENECIENTE A LA UGT – ESPE”**

Chicaiza Byron

Presentación de la Monografía

Diciembre, 2019

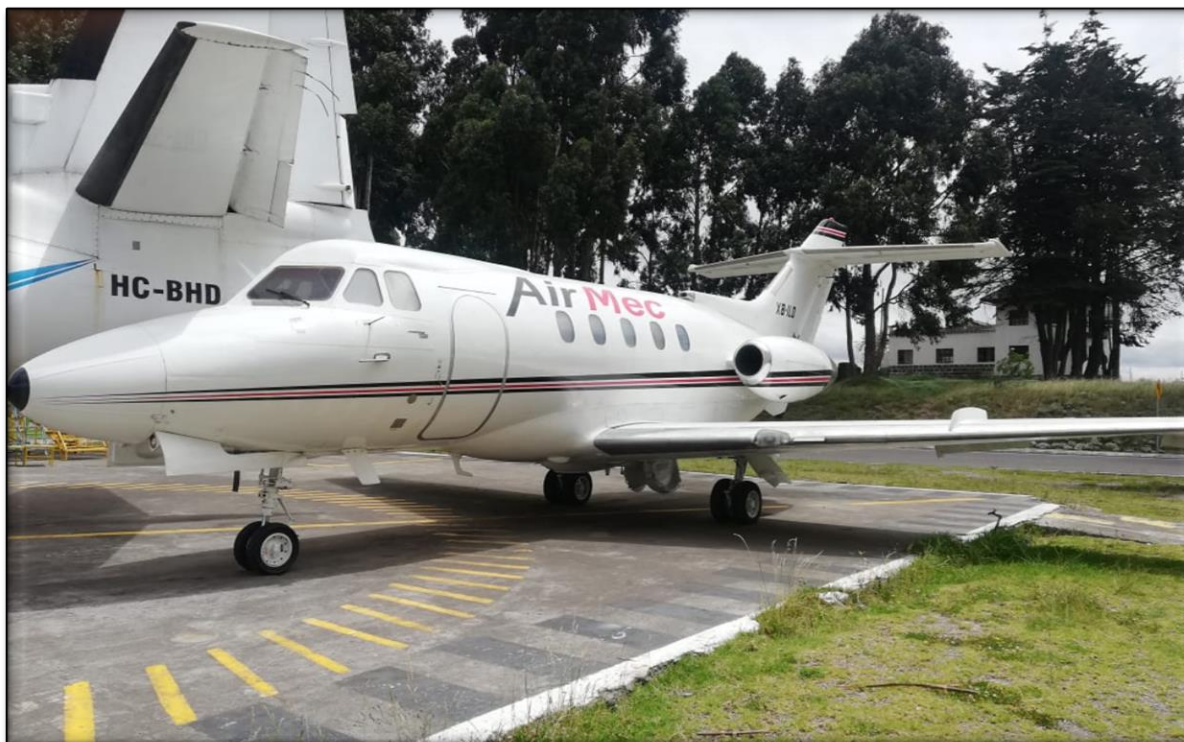
**AERONAVE HAWKER SIDDELY**

- Condiciones no aeronavegables.
- Mantenimiento no adecuado.
- Rajaduras, hundimientos y discrepancias adicionales
